University of Canterbury

Experimental Study on the Seismic Performance of Low Damage Systems for Non-structural Light Framed Plasterboard Partition Walls

ENEQ690 Master's Thesis

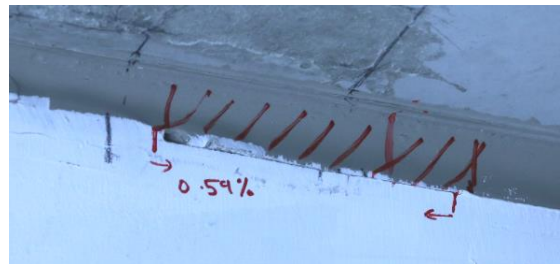
(b) Sealant de-bonding

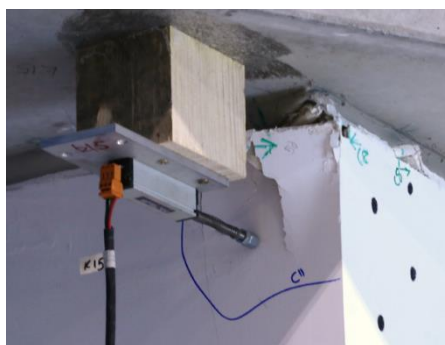
(e) Wallboard damage

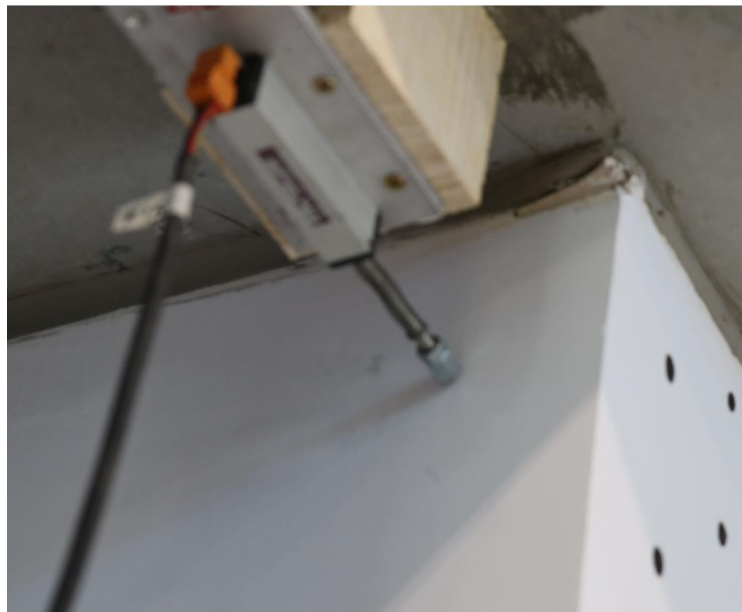
Figure B.3 Specimen A1 – Prior to test start - Defects in sealant bond - location 7

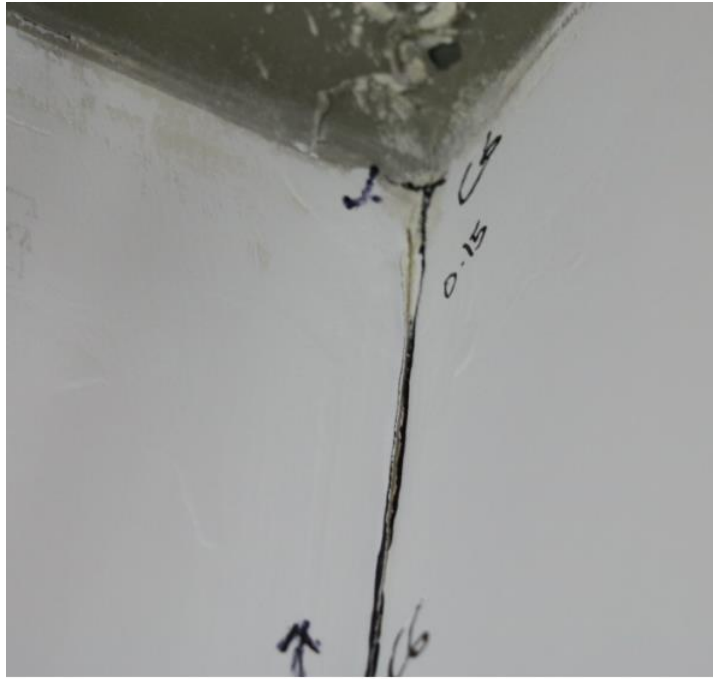
Figure B.6 Specimen A1 – Step 8 – DS1b: Plaster cracking and joint tape – location 11

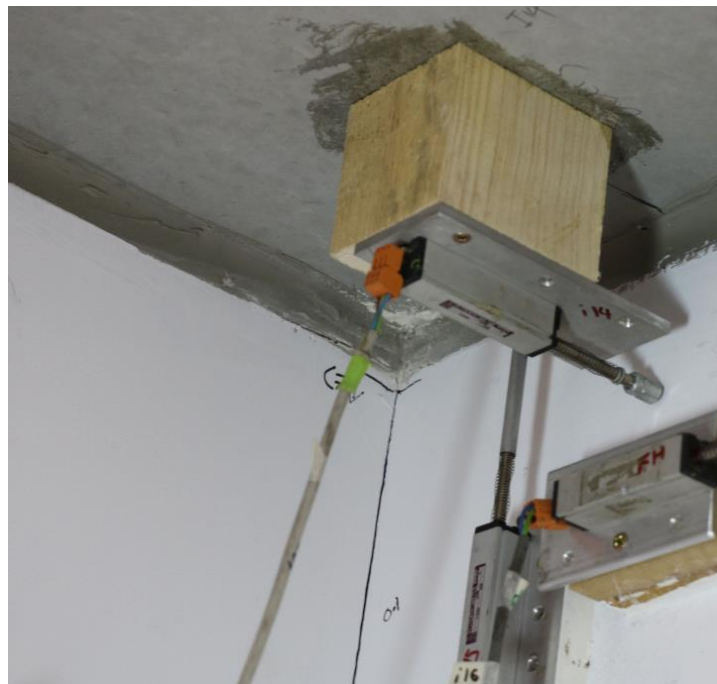
Figure B.7 Specimen A1 – Step 8 – DS1a: Sealant debonding at corner junction – location 15

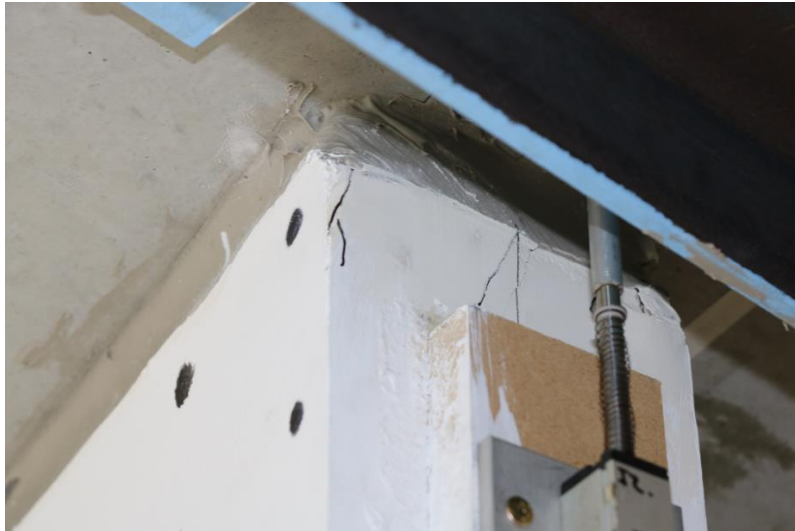
Figure B.8 Specimen A1 - Step 8 - DS2: cracking of wallboard at wall end from pushing from track – location 21

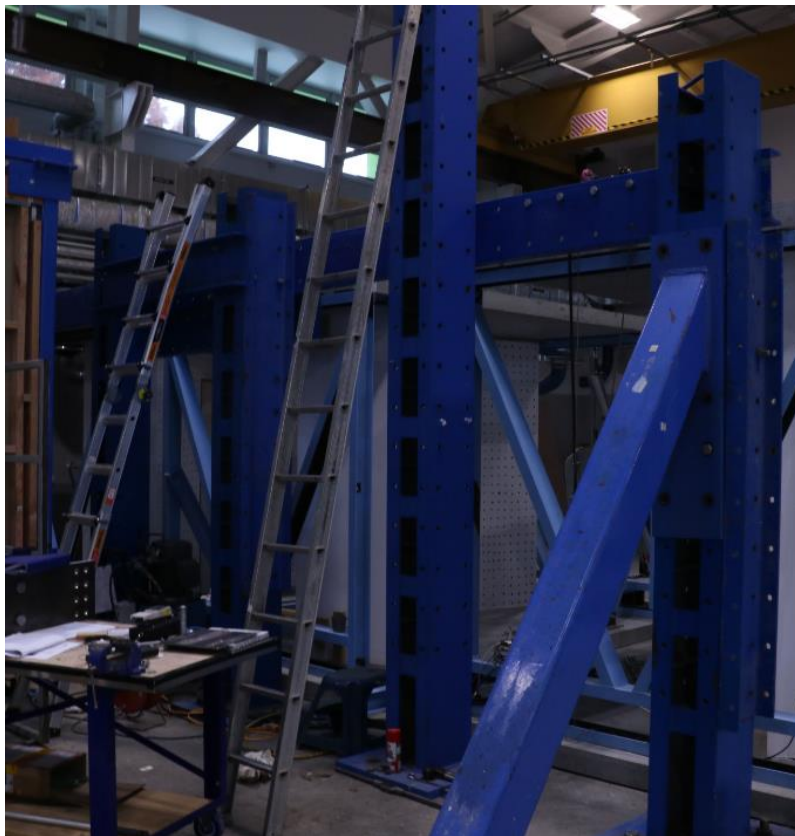
Figure B.9 Specimen A1 - Step 8 to 9 – stiffening of reaction frame to reduce hysteretic noise

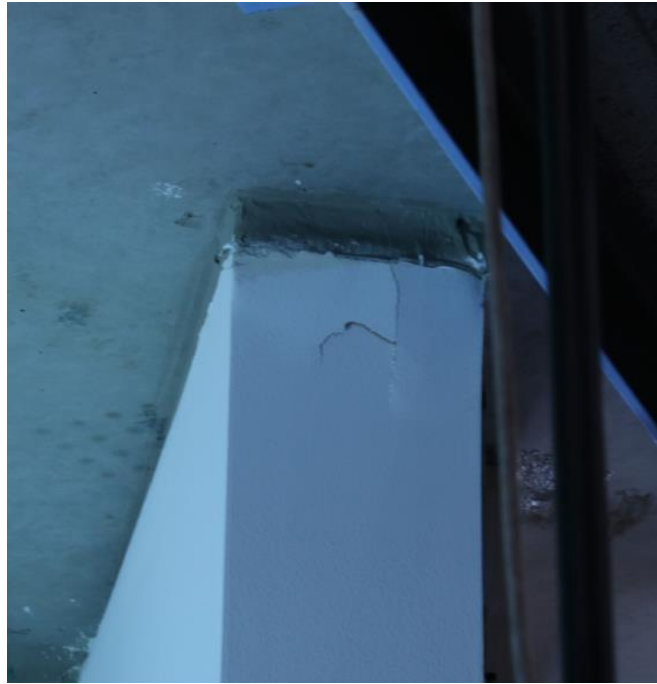
Figure B.12 Specimen A1 – Step 11 – DS2: wallboard damage due to top track pushing through—
location 9

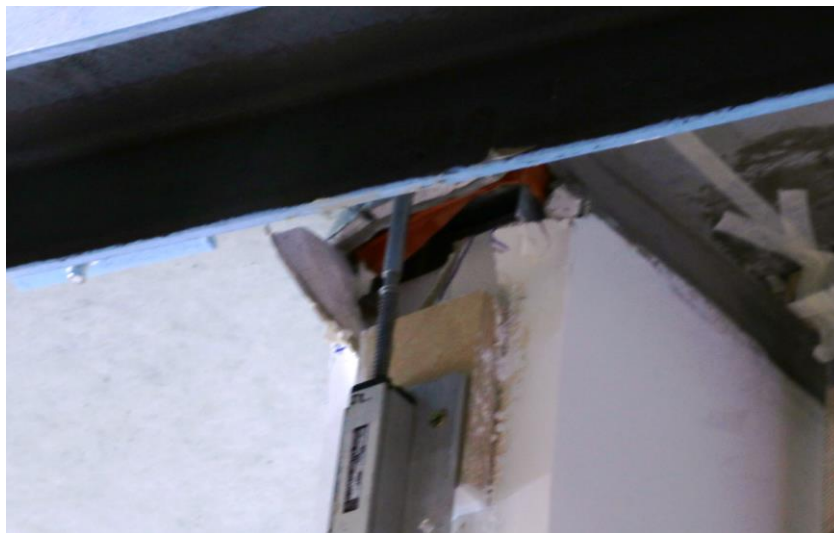
Figure B.13 Specimen A1 - Step 12 --further development of DS2: cracking of wallboard at wall end
from pushing of track – location 21

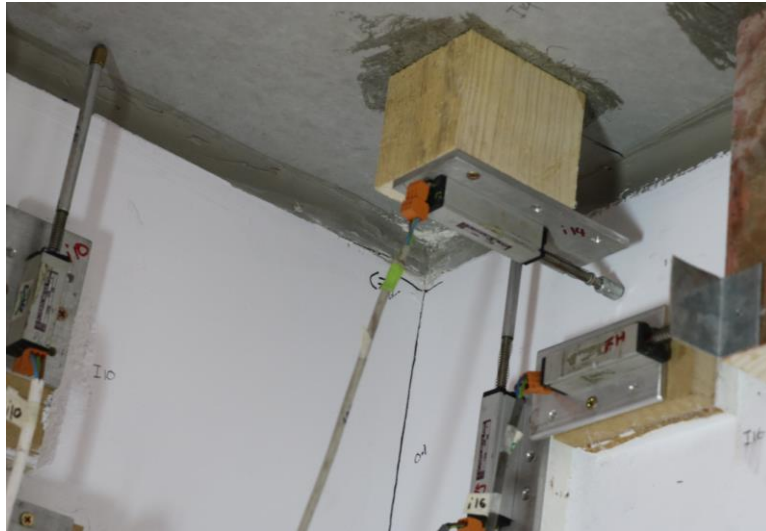
Figure B.14 Specimen A1 - Step 8 – 0.36% drift - DS1a: onset of sealant debonding requiring replacement

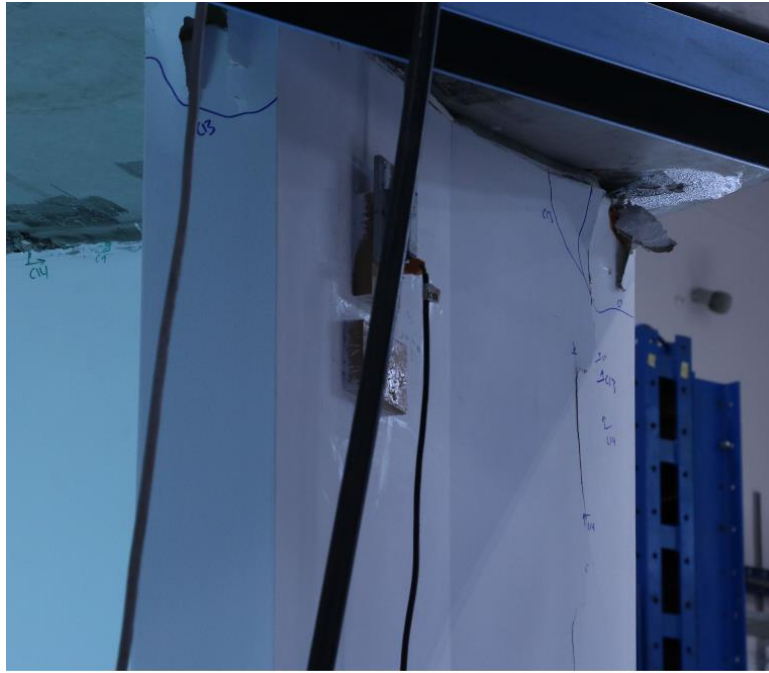
Figure B.18 Specimen A1 - Step 15 --Near collapse – locations 6-11

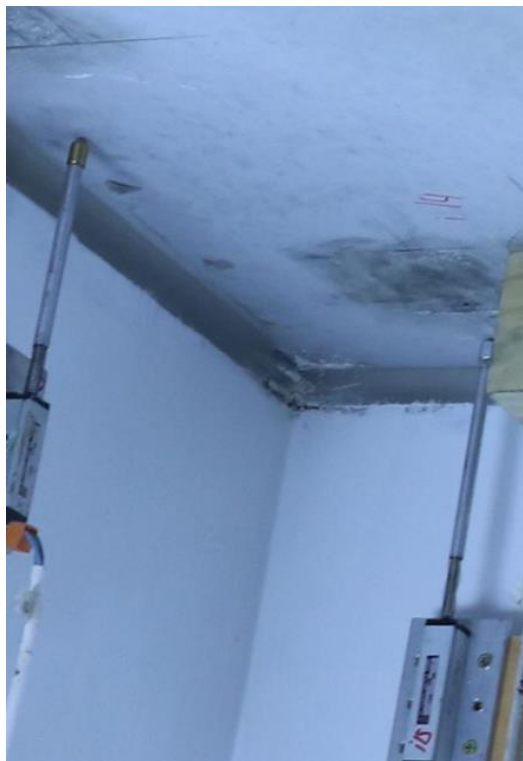
Figure B.23 Specimen A2 – Prior to test start –Defects in sealant bonding at corner junction – location

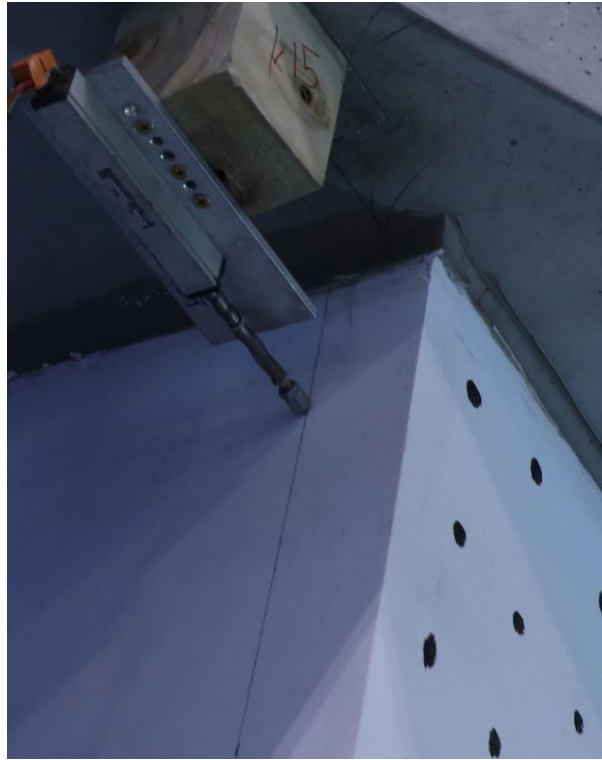
Figure B.24 Specimen A2 – Step 7– DS2: wallboard damage - location 7

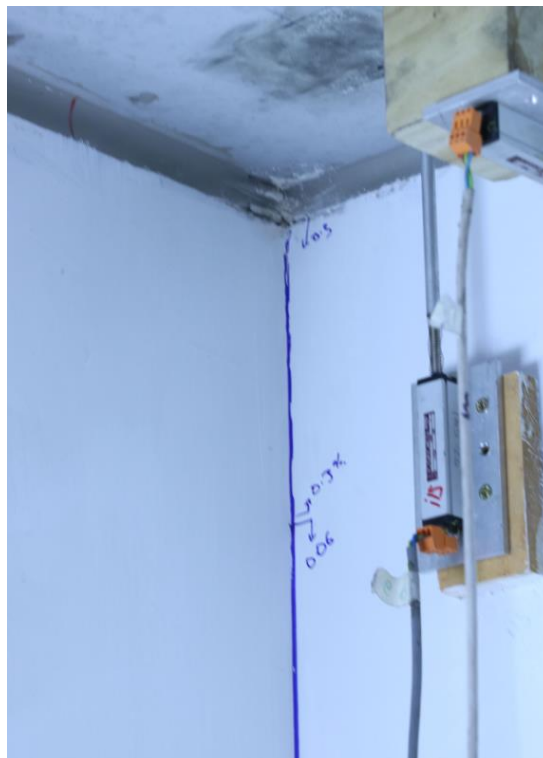
Figure B.25 Specimen A2 – Step 7– DS0: hairline paint cracking (behind blue marker)- location 15

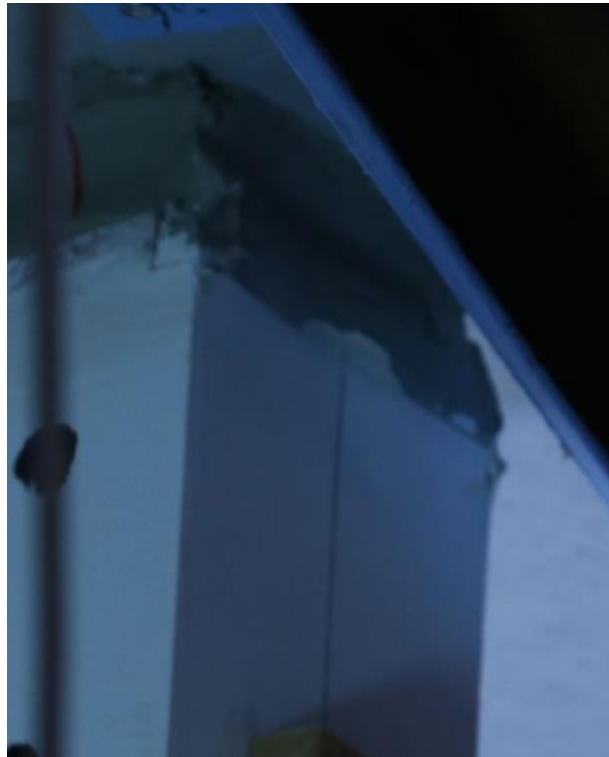
Figure B.27 Specimen A2 – Step 9 – DS2: Wallboard Damage – location 21

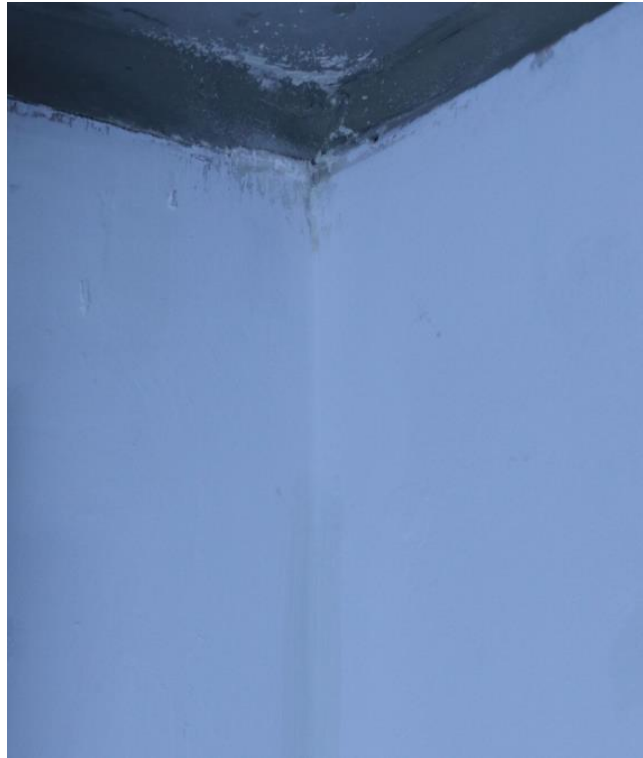
Figure B.28 Specimen A2 – Step 10 – DS0: Hairline paint cracking – location 11

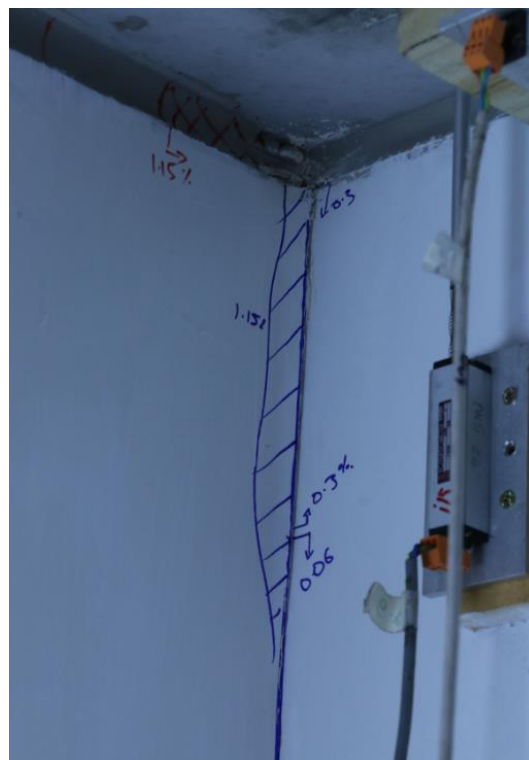
Figure B.31 Specimen A2 – Step 11 – DS1a,b: debonding of sealant at plaster cracking at intersection – location 15

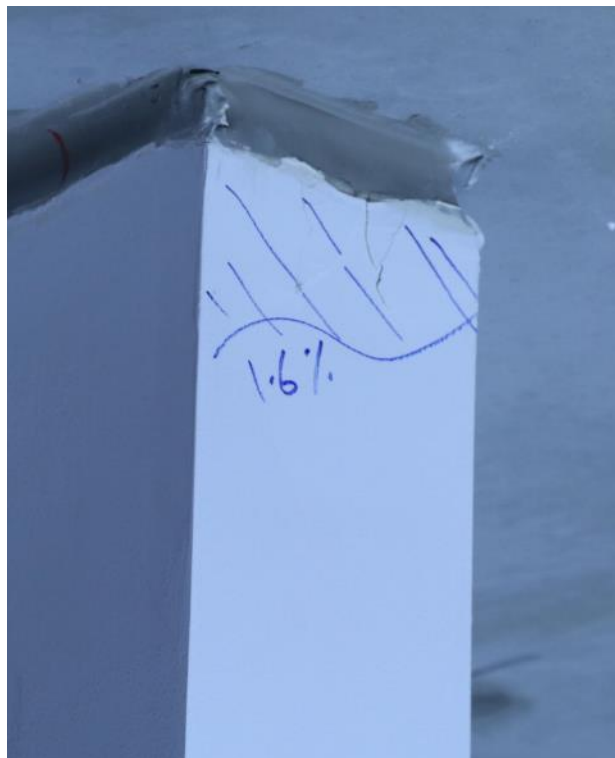
Figure B.33 Specimen A2 – Step 12 – DS2: wallboard damage due to top track pushing through–
location 16

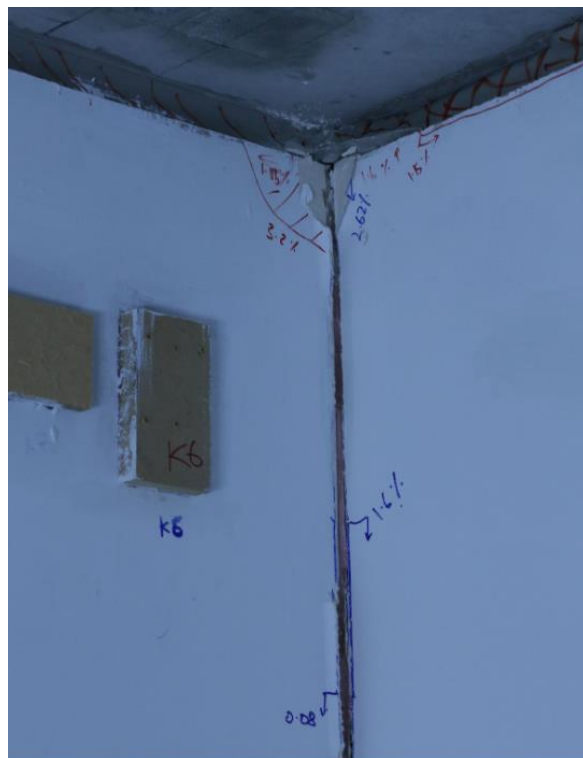
Figure B.37 Specimen A2 - Step 15 — DS2: wallboard damage – location 11

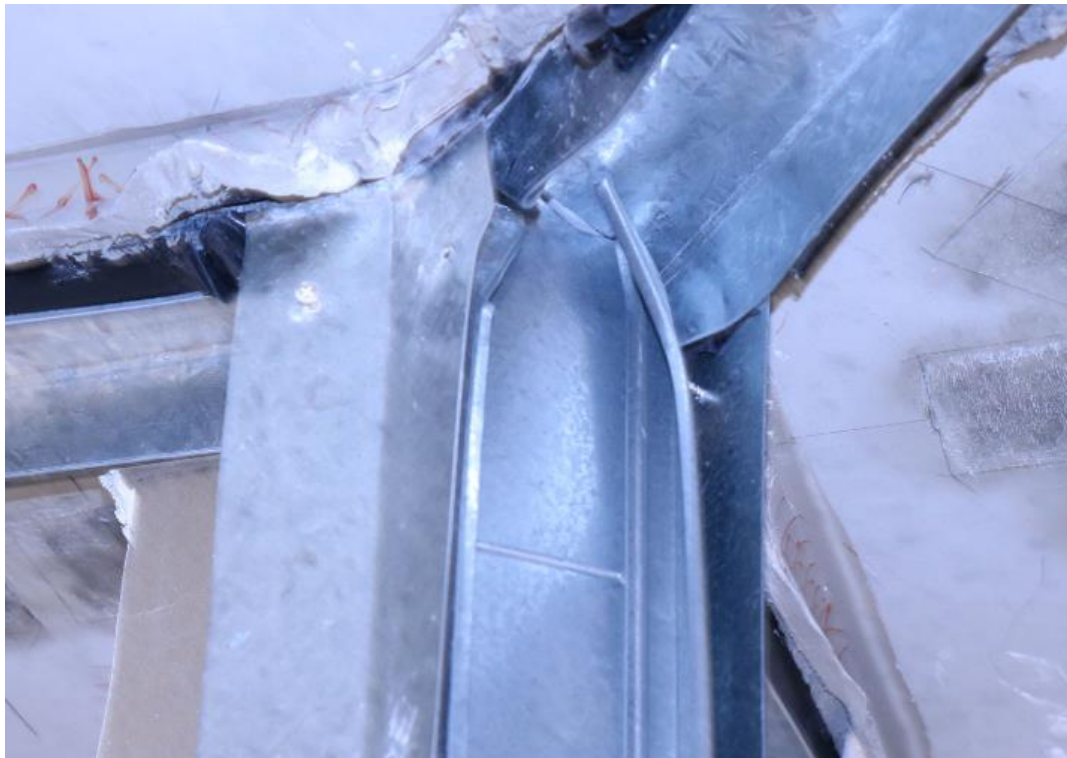
Figure B.41 Specimen A2 – Post-test framing inspection —buckling of studs at Y-junction in angled wall– locations 2 & 19

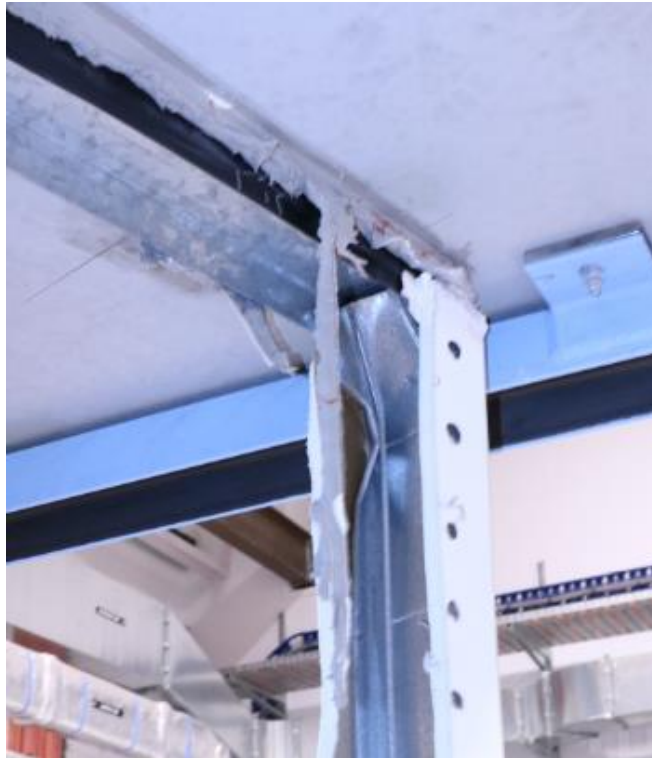
Figure B.42 Specimen A2 – Post-test framing inspection – buckling of stud at end of angled wall– location 21

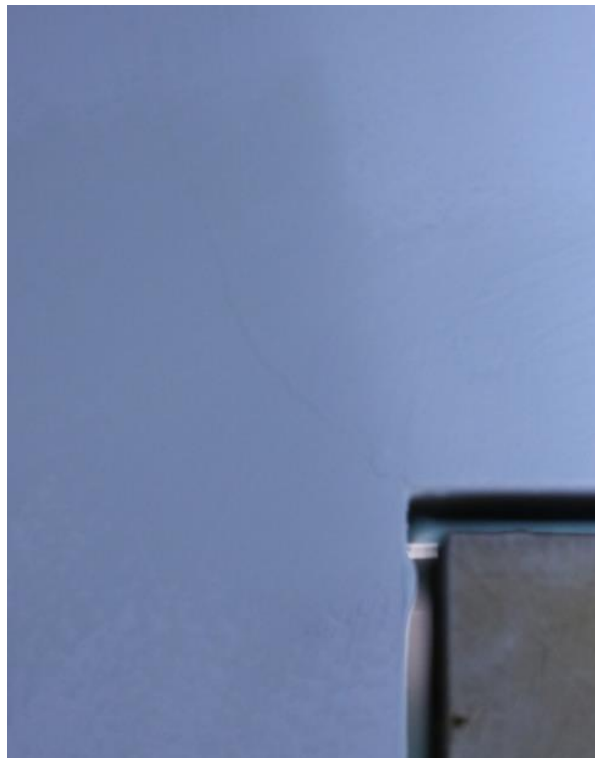
Figure B.47 Specimen A3 – Step 3– DS0: hairline paint cracking - location 13

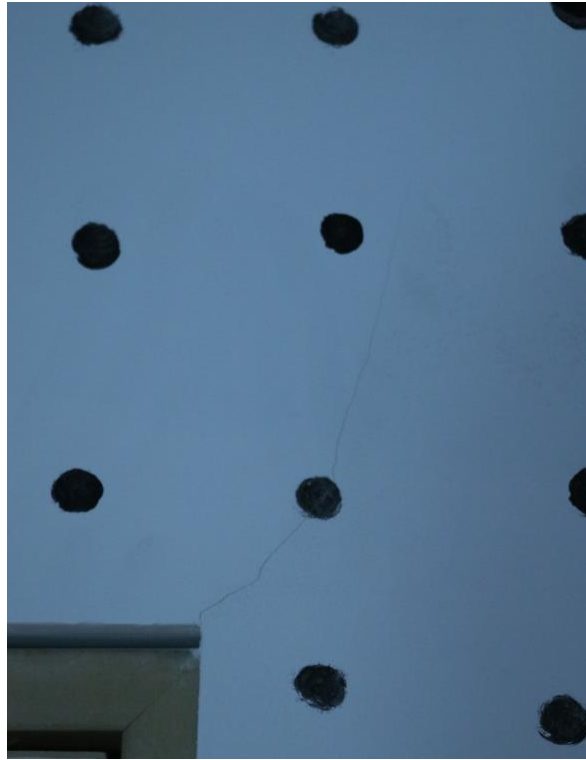
Figure B.48 Specimen A3 – Step 6 – DS00: Hairline paint cracking – location 4

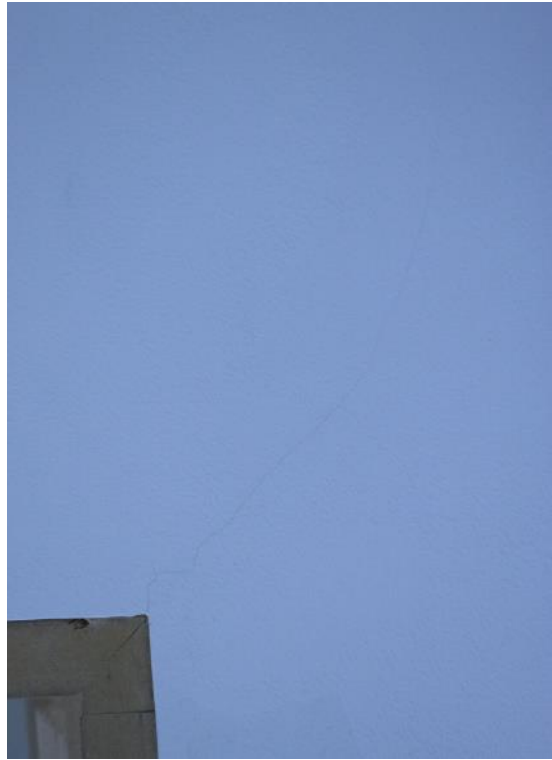
Figure B.50 Specimen A3 – Step 7 – DS2: Wallboard Damage – location 13

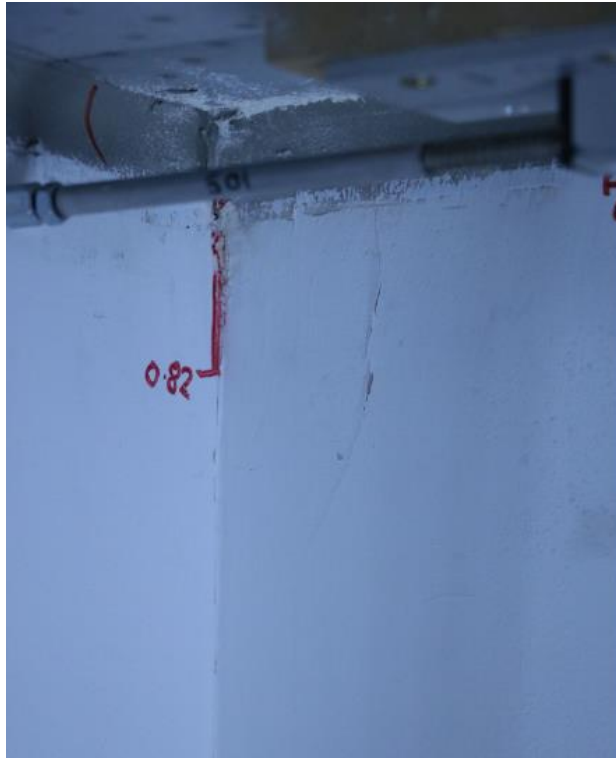
Figure B.56 Specimen A3 - Step 11 --DS2: Wallboard damage – location 11

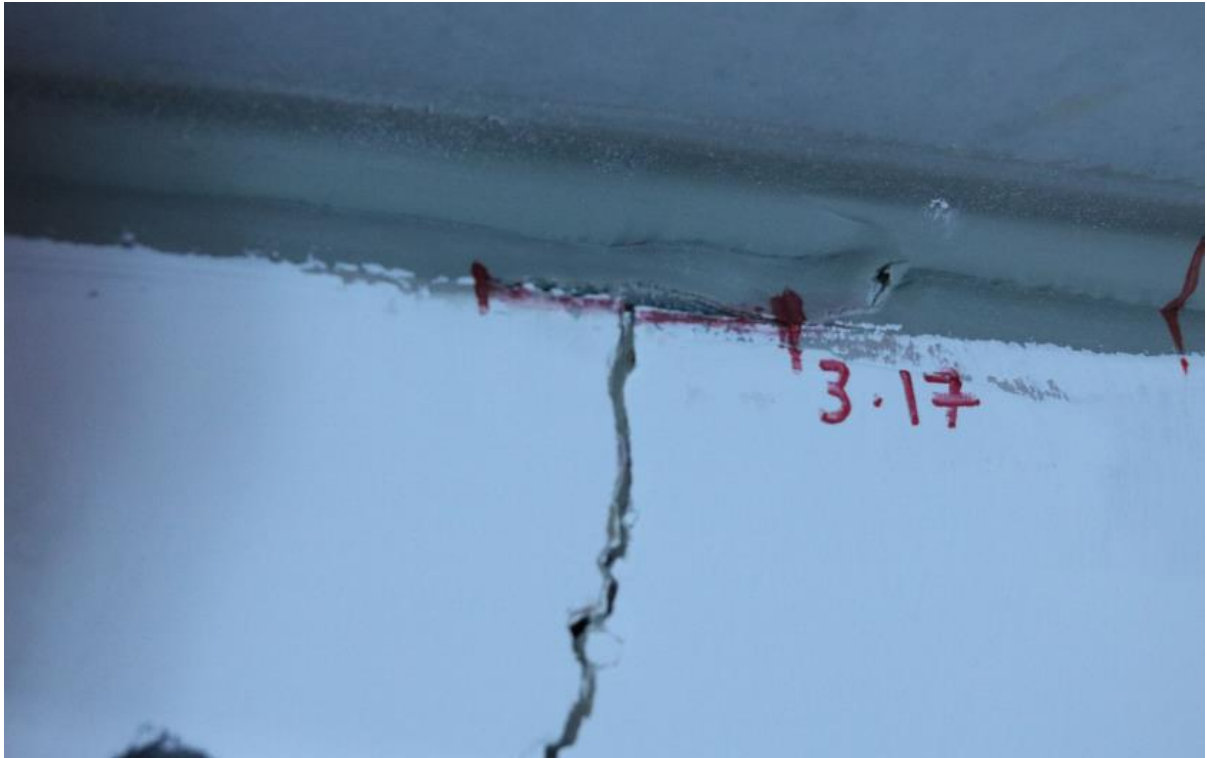
Figure B.60 Specimen A3 - Step 14– DS1a: Debonding of sealant– location 4

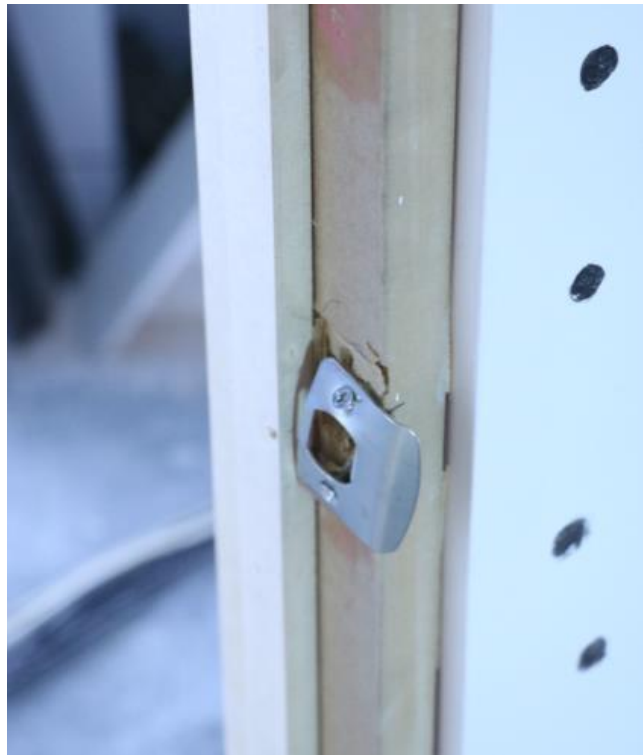
Figure B.61 Specimen A3 - Step 14 – DS3*: damage to door framing – location 4

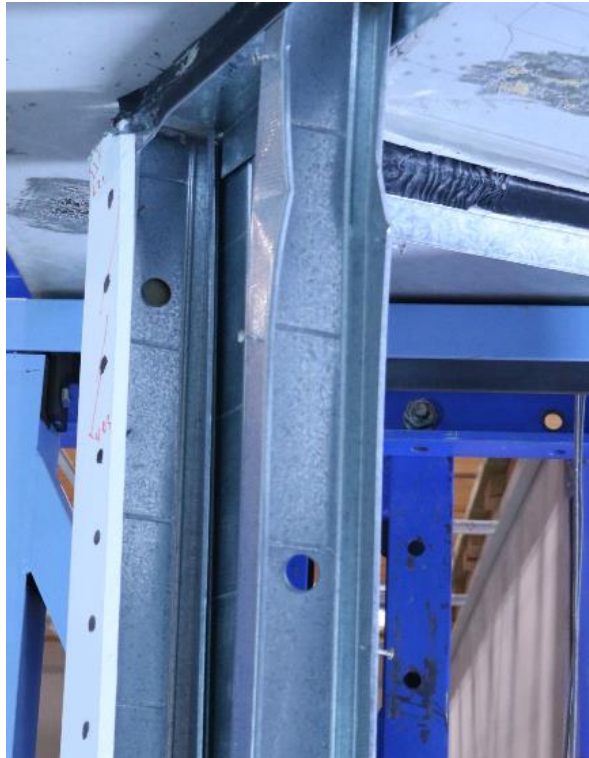
Figure B.66 Specimen A2 – Post-test framing inspection —buckling of studs at L-junction – locations

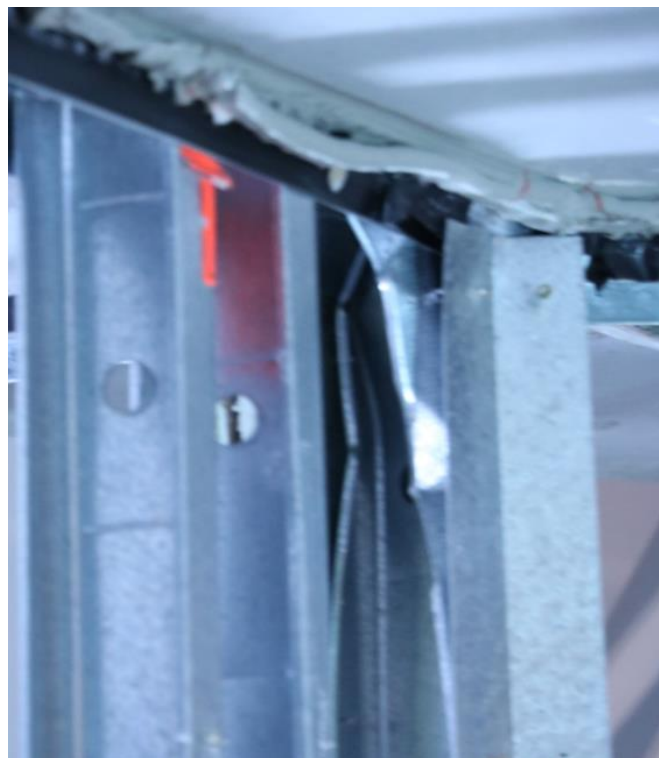
Figure B.67 Specimen A2 – Post-test framing inspection – buckling and bending of study flanges of stud at end of main wall at Y-junction – location 2 & 15

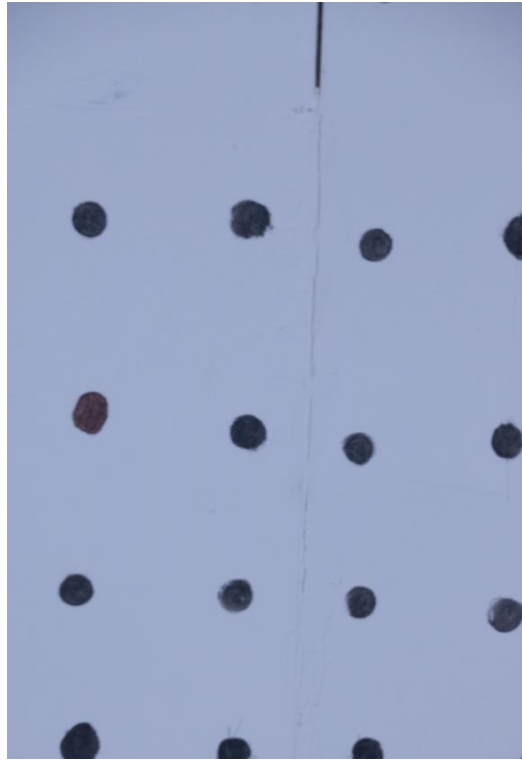
Figure C.4 Specimen B1 – Step 8 – DS0: Hairline paint cracking at Y-junction - location 2

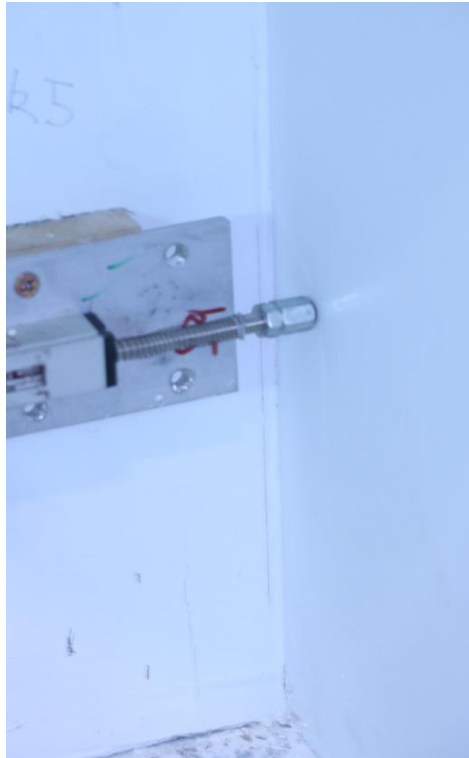
Figure C.6 Specimen B1 – Step 8 – DS0: Hairline paint cracking at L-junction - location 11

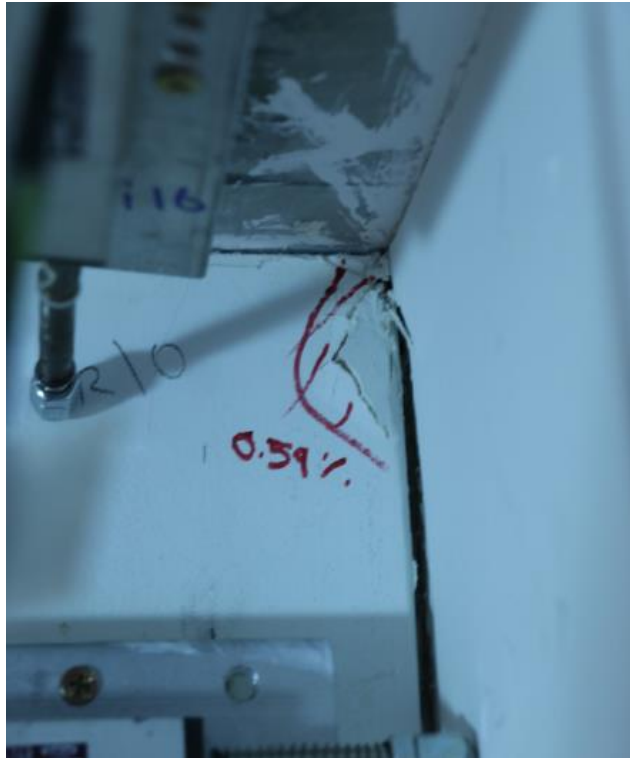
Figure C.8 Specimen B1 – Step 9 – DS1b: Plaster cracking at L-junction top corner- location 11

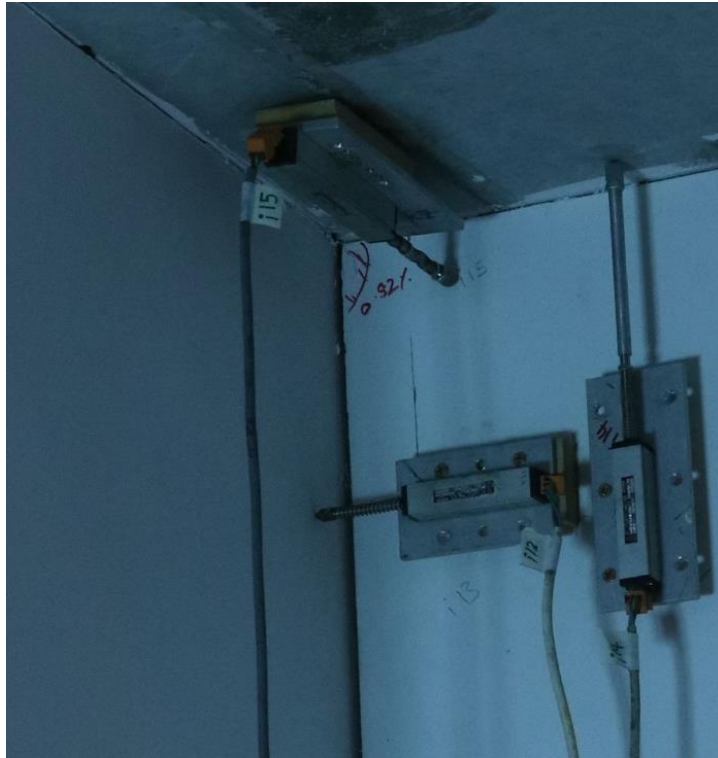
Figure C.10 Specimen B1 – Step 10 – DS1b: Plaster cracking at Y-junction top corner- location 15

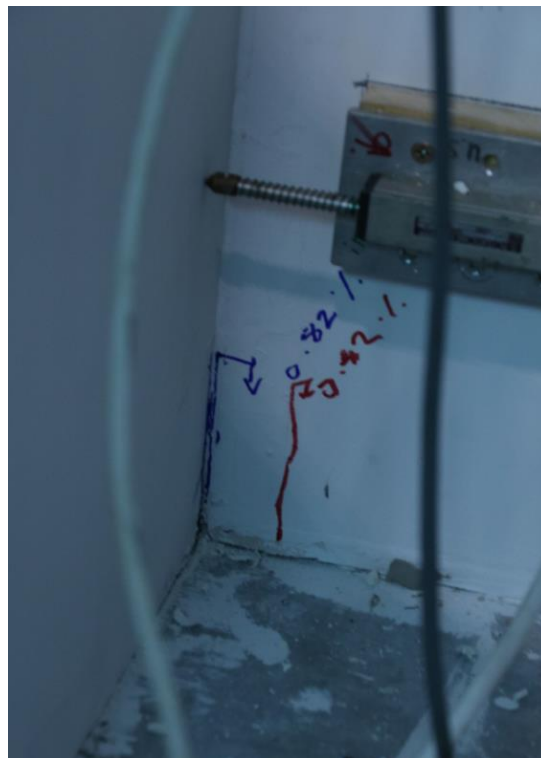
Figure C.11 Specimen B1 – Step 10 – DS1a & b: Debonding of gap filler and plaster cracking along L-trim at Y-junction bottom corner- location 15

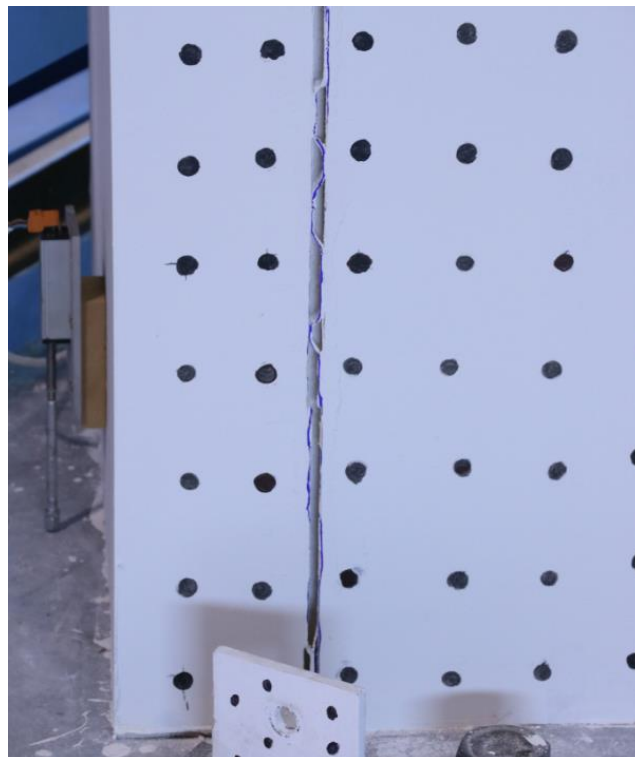
Figure C.13 Specimen B1 – Step 11 – DS2b: Excessive residual gap development at L-junction – location 6

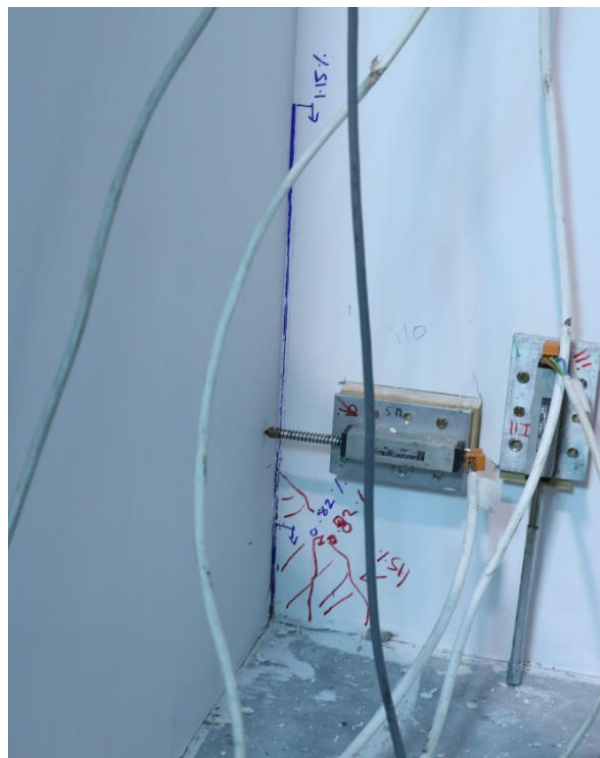
Figure C.15 Specimen B1 – Step 11 – DS2a: Wallboard crushing at toe – location 15

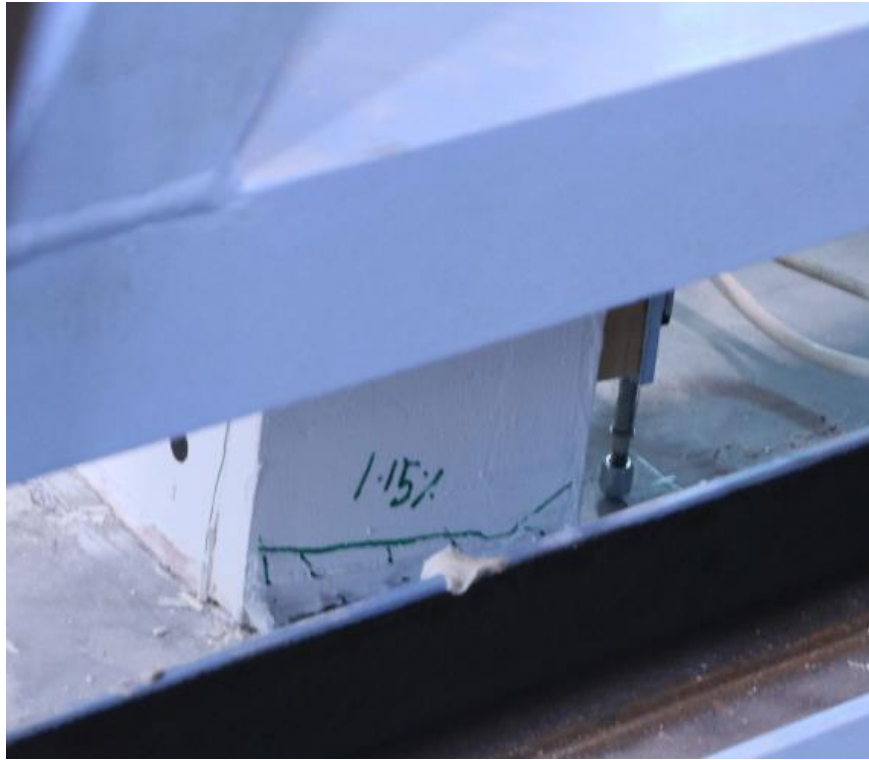
Figure C.16 Specimen B1 – Step 11 – DS2a: Wallboard crushing at toe – location 21

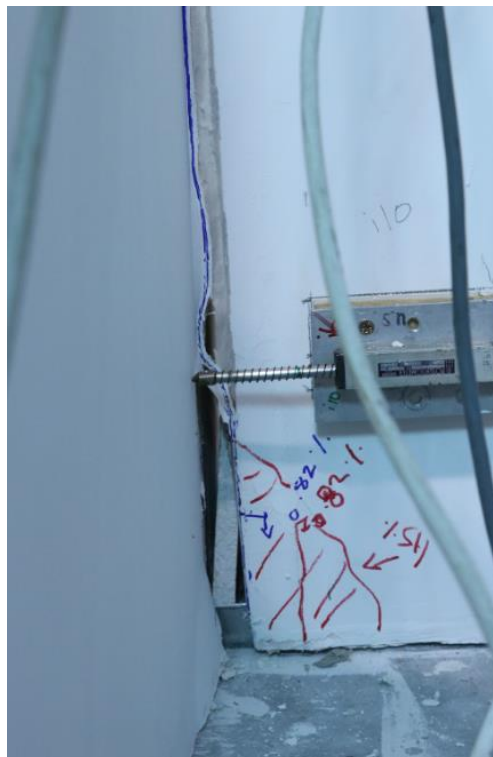
Figure C.21 Specimen B1 – Step 14 – DS2a: damage to vertical plasterboard packing strips – location

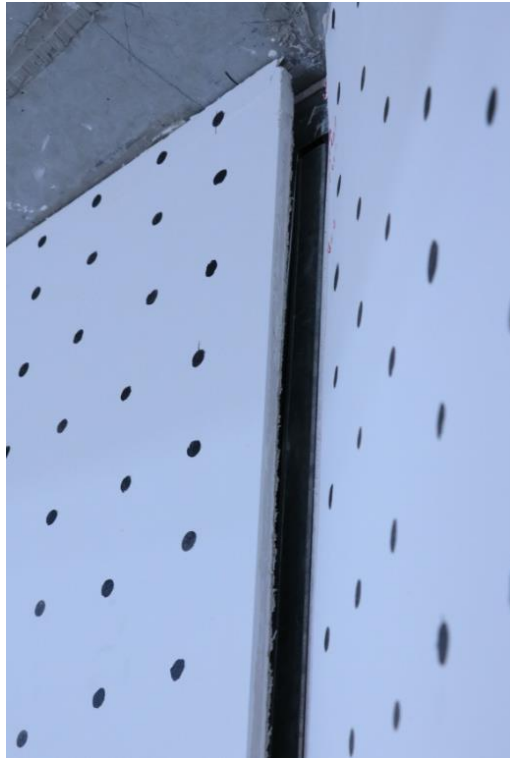
Figure C.24 Specimen B1 – Step 16 –DS1c: linings detached from studs – location 2

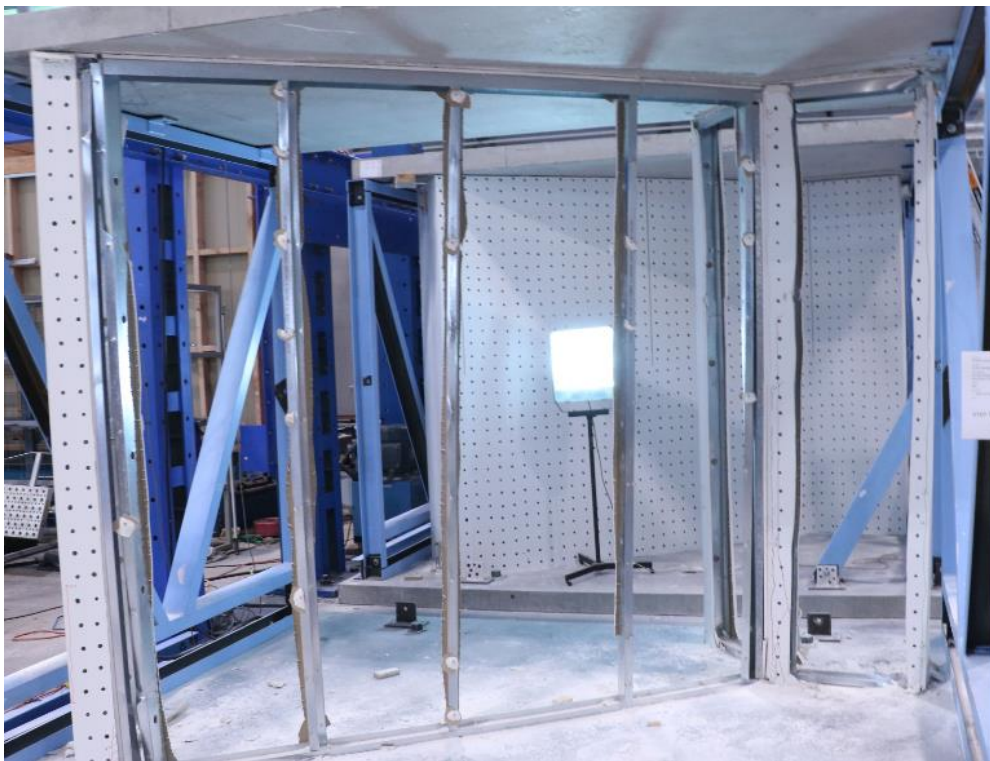
Figure C.27 Specimen B1 – Post-test framing inspection —wall after removal of linings

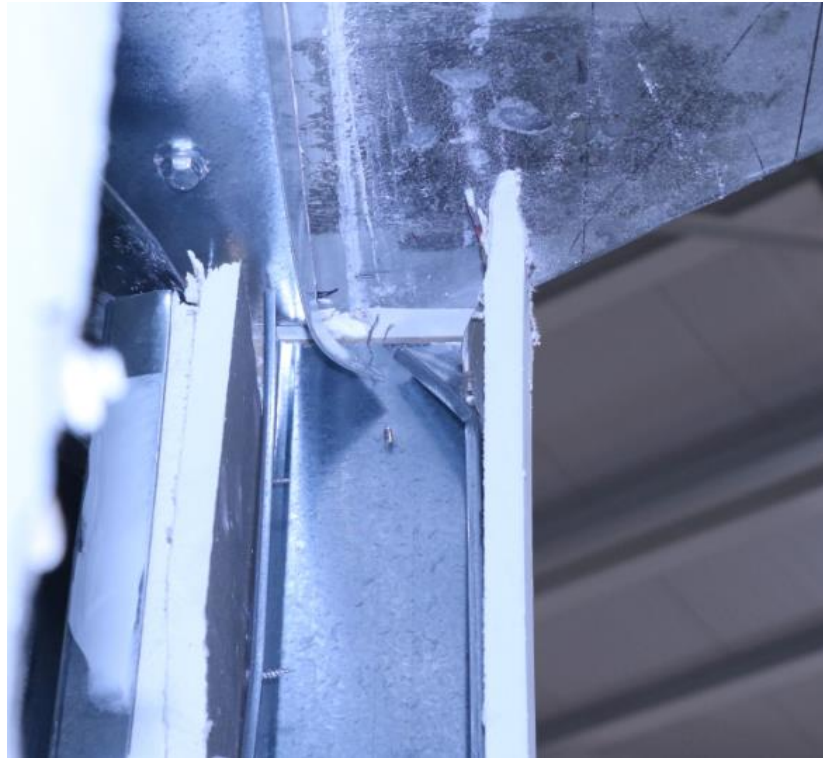
Figure C.28 Specimen B1 – Post-test framing inspection —bending of stud and track flanges at top of L-junction – locations 6, 7, & 11

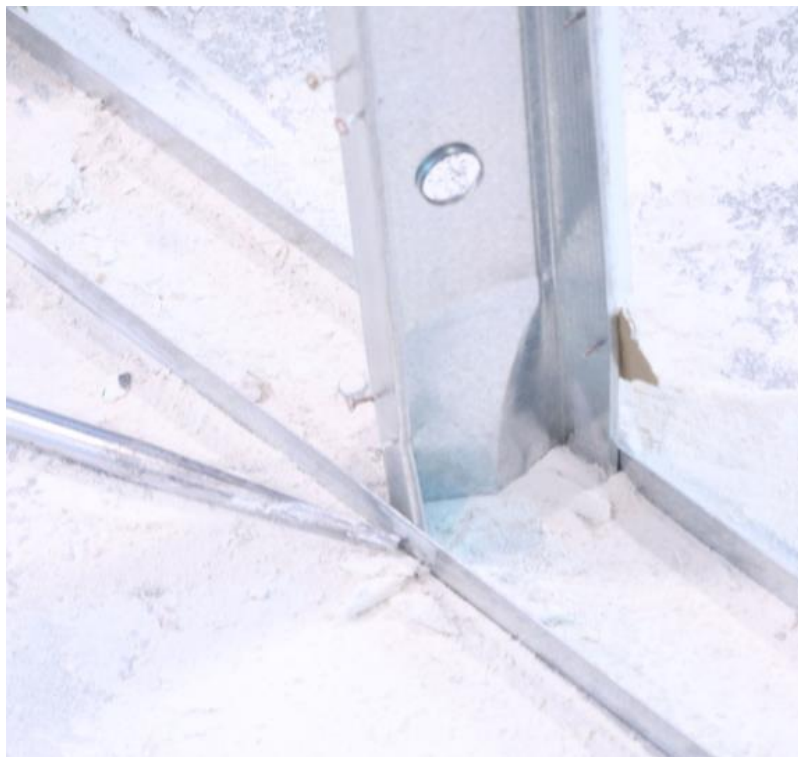
Figure C.29 Specimen B1 – Post-test framing inspection —bending of stud web at bottom due to pushing against bottom rack anchor bolt heads – locations 5 & 12

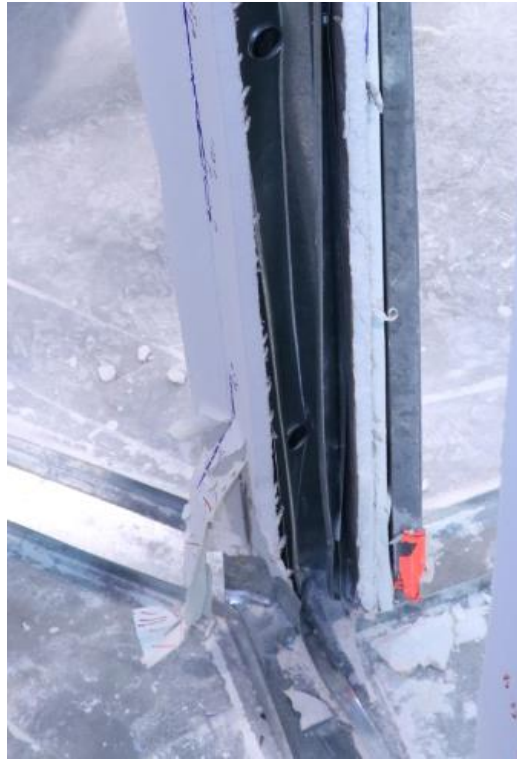
Figure C.30 Specimen B1 – Post-test framing inspection —bending of stud webs and bottom track flanges due to pushing of the main wall against the Y- junction – locations 2, 15, & 19

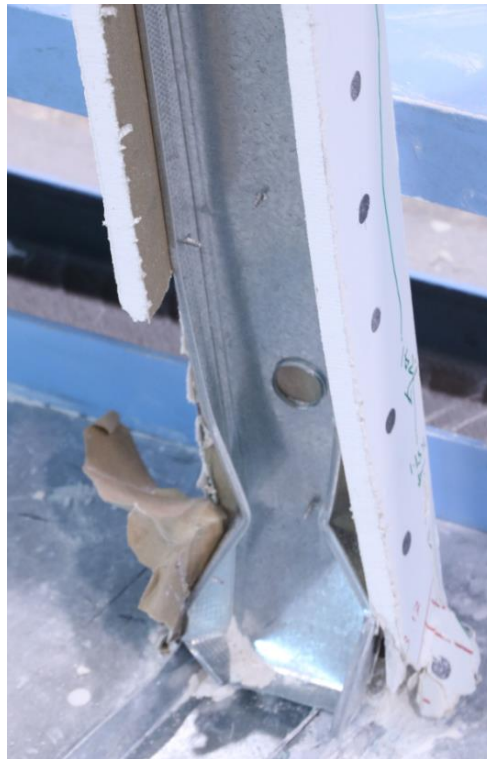
Figure C.31 Specimen B1 – Post-test framing inspection —buckling of studs at bottom of end of angled wall – location 21

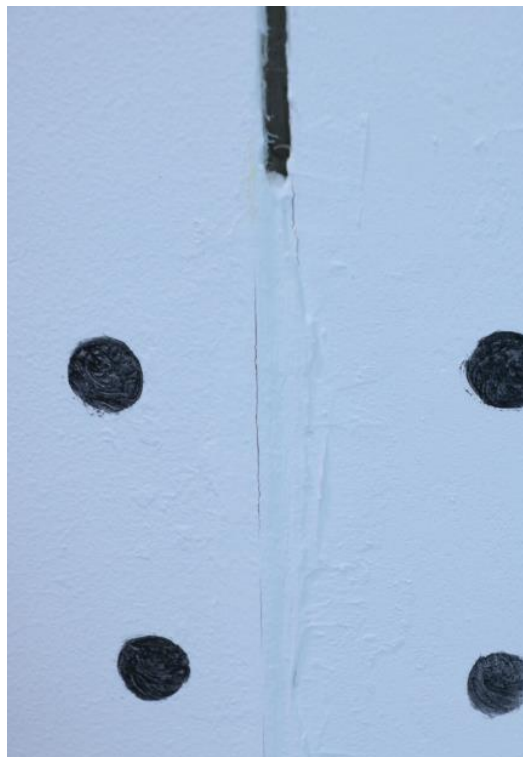
Figure C.35 Specimen B2 – Step 9 – DS0: Hairline paint cracking at L-junction - location 6

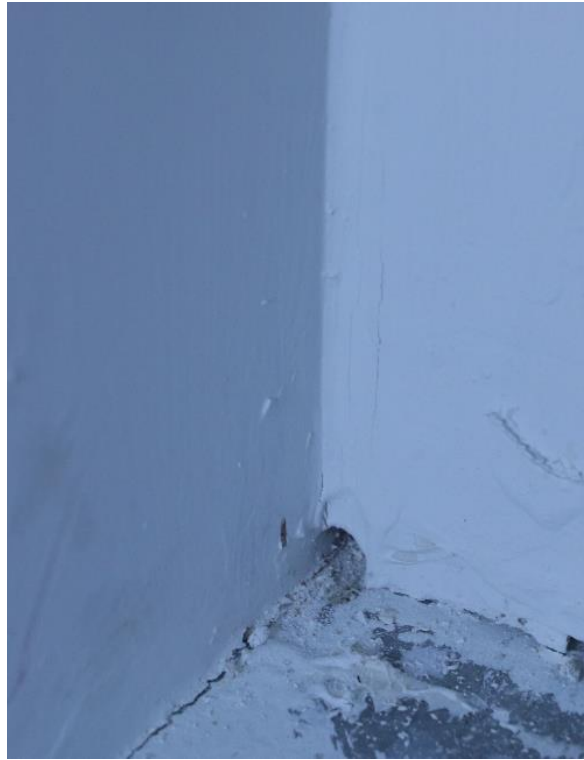
Figure C.36 Specimen B2 – Step 9 – DS0: Hairline paint cracking at Y-junction - location 15
